October 15, 2010

Subject: Hydrologic, Hydraulic, and Geotechnical Assessment for Argentine Mine / St. Louis Tunnel Sediment Settling Ponds, near Rico, Colorado  
Contract No. EP-W-05050, START 3, Region 8  
Project No.: 22241923

URS was also asked to conduct a site visit to observe the existing condition of select sediment settling pond embankments, specifically Pond 18. Our observations were to be limited to those visible features on the slopes, crest and down stream areas that appear to be related to embankment stability. Our primary focus was to be on drainage patterns, evidence of subsidence, erosion, seepage, and surface instability. The following summarizes our understanding of the historical operation of the settling ponds, our observations, followed by conclusions and recommendations. Photographs documenting the existing condition of the pond embankments are located in Attachment 4.

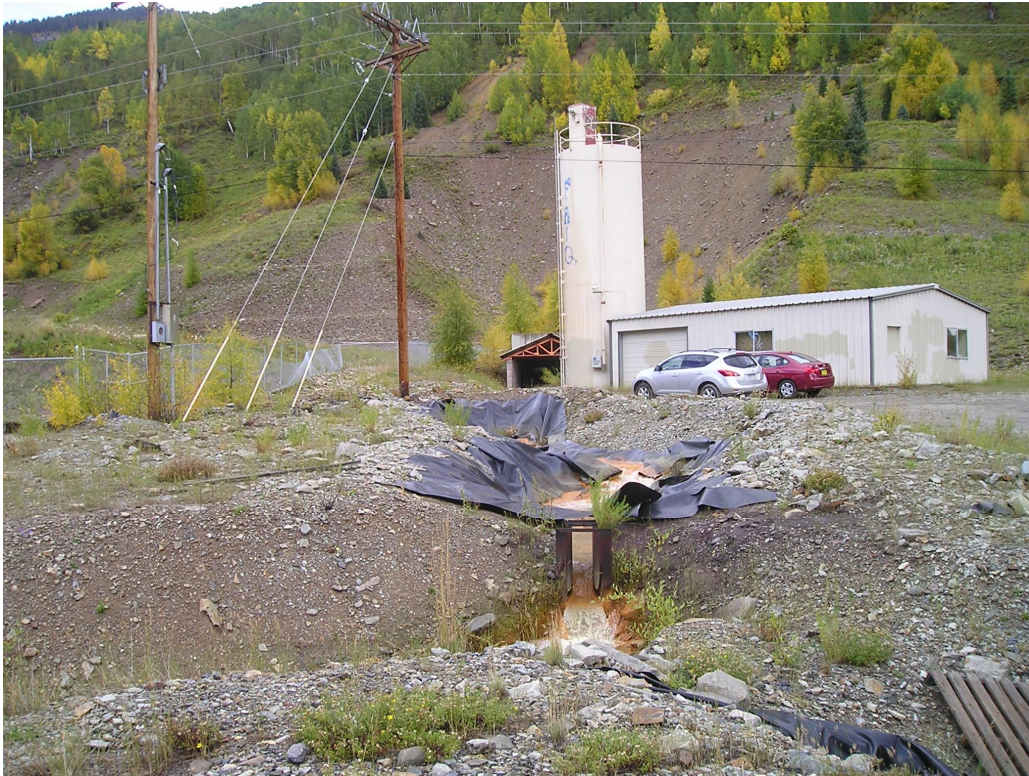
1. Discharge from the St. Louis tunnel to holding pond above Pond 18.

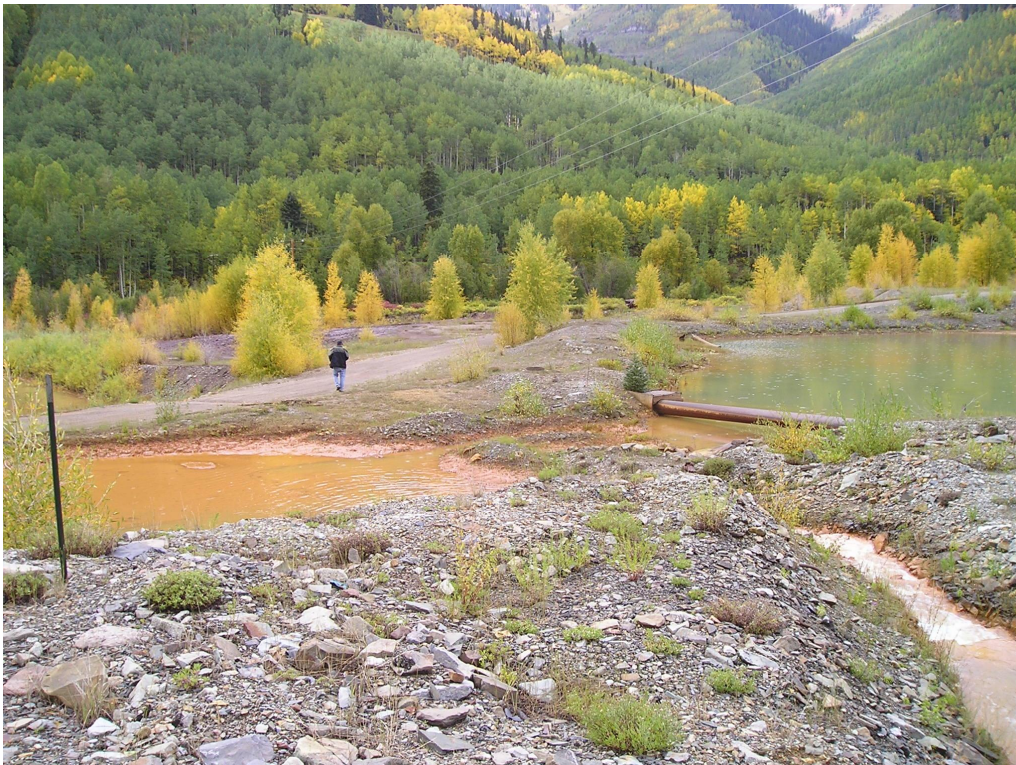
2. Discharge from the St. Louis tunnel to holding pond above Pond 18.

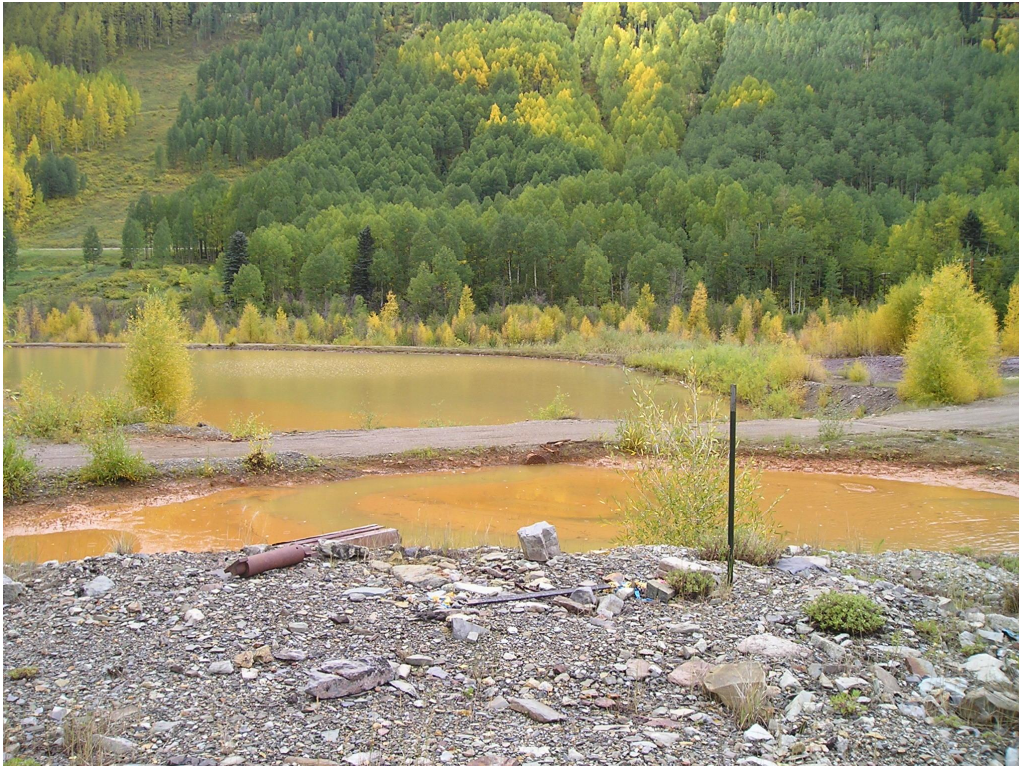
3. Holding pond (front) above Pond 18 (back).

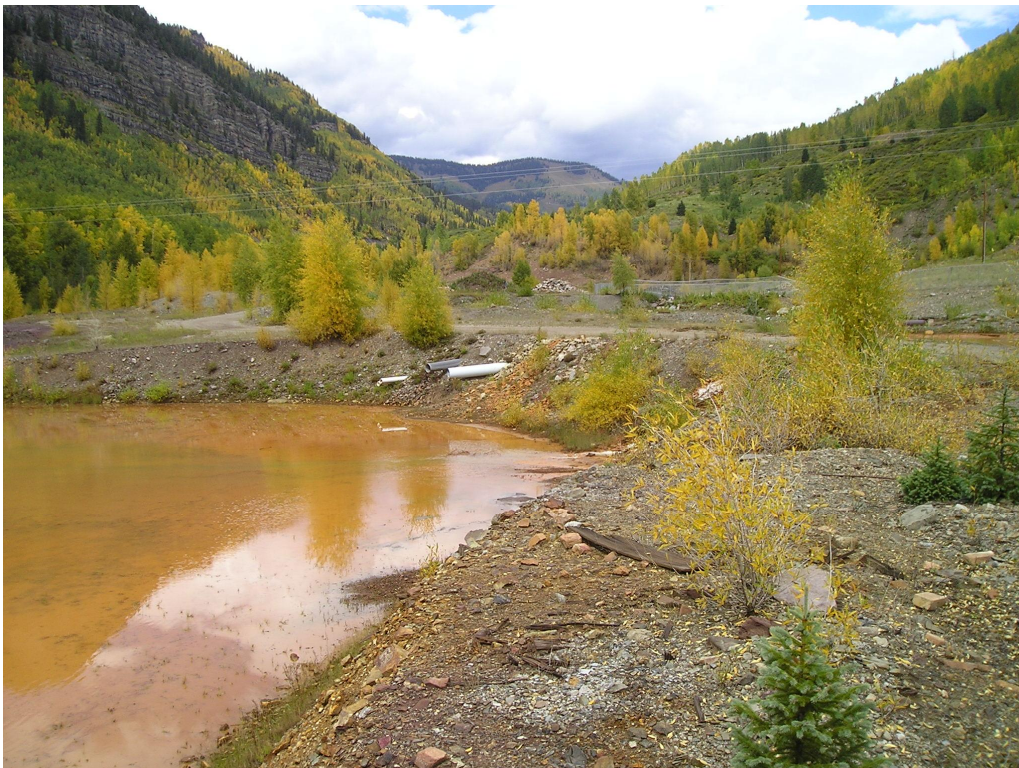
4. Culverts discharging from holding pond above Pond 18 into Pond 18.

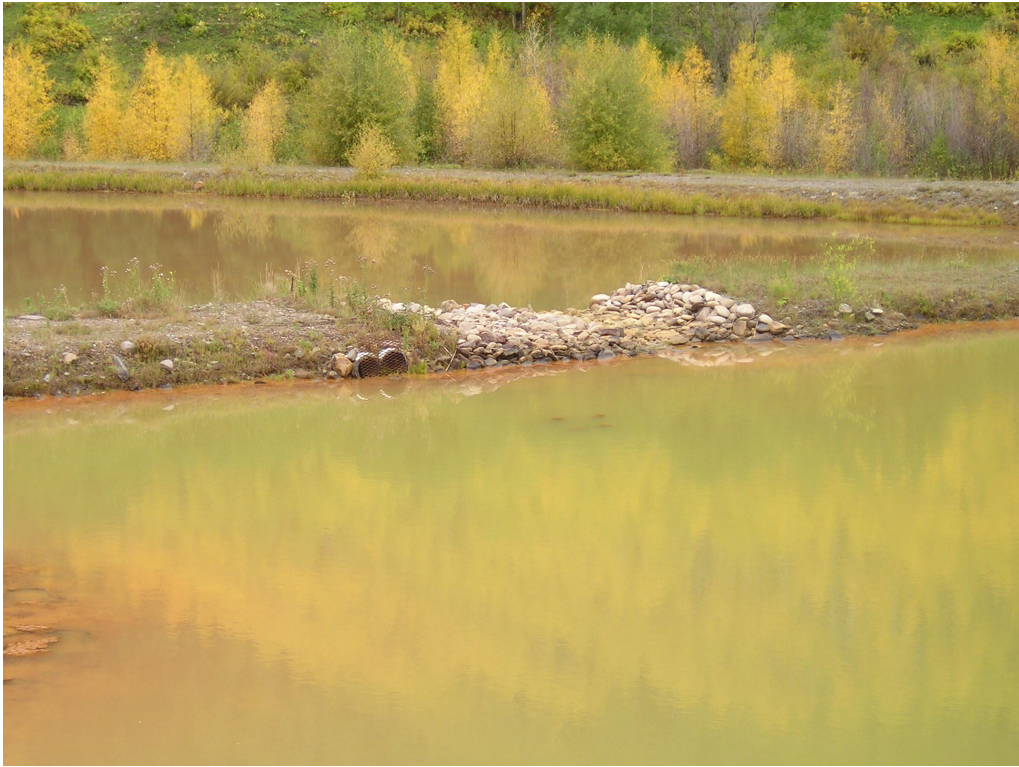
The spillway consists of a broad crest weir approximately 5 to 10 feet across and lined with cobbles ranging in size from 6 to 18 inches. Three culverts constructed within the embankment, near the spillway, also discharge water from Pond 18 to Pond 15, see Attachment 1. Two culverts, side-by-side, located south of the spillway appeared to be functional. Both contained soil as a result of in-silting and appeared to be operating at approximately three-quarters of their design capacity, when flowing full. The third culvert was situated directly beneath the main spillway and was actively spilling water. The main spillway was not spilling water, but appeared to have carried water at some point, based on discoloration of the rip rap. At the time of the site visit, the main spillway and associated culverts were free of debris blocking the inlet. The spillway appeared to be in good condition with a small amount of debris located at the discharge point to Pond 15.

5. Discharge culverts and spillway for Pond 18.

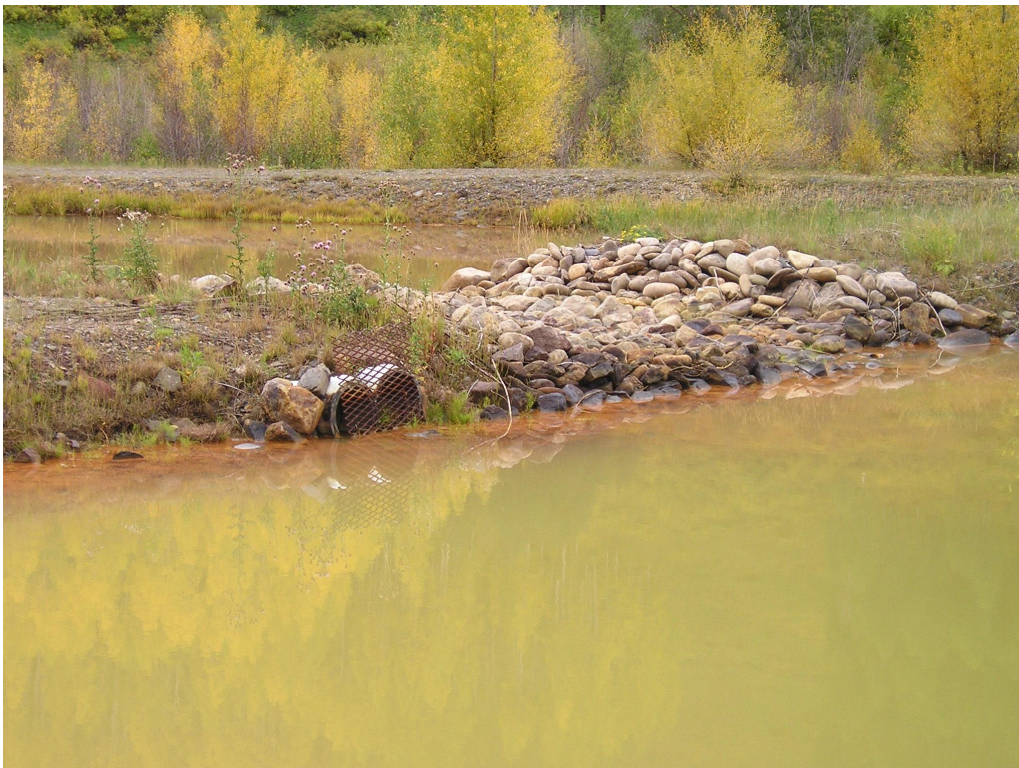
6. Discharge culverts and spillway for Pond 18.

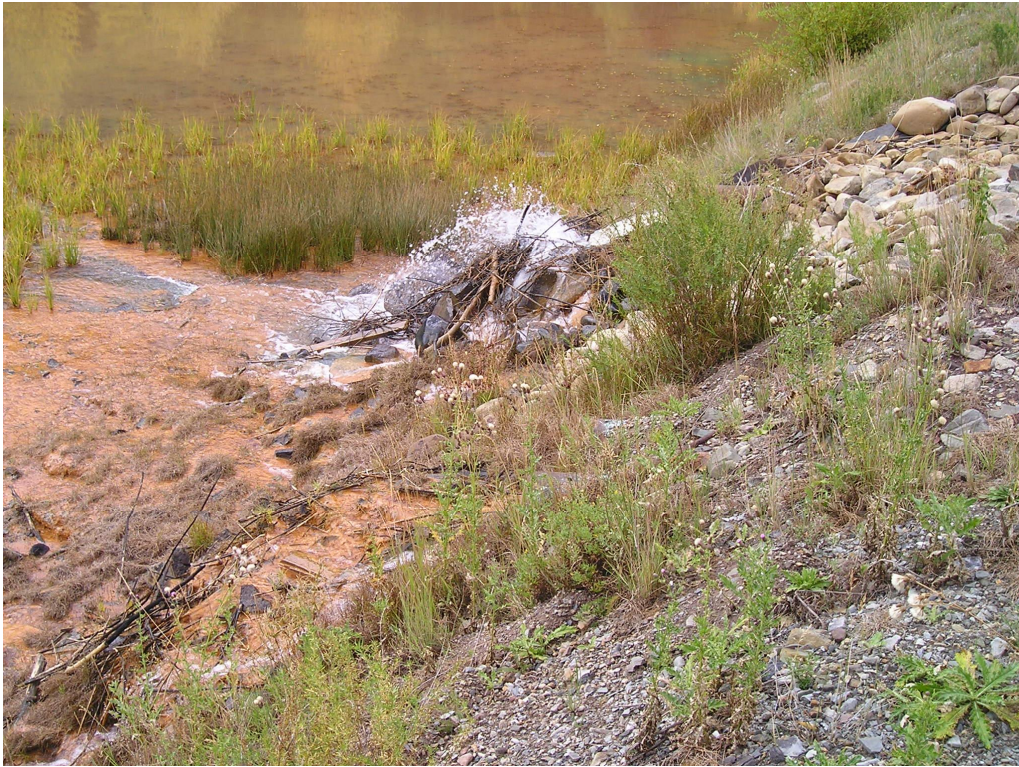
7. Downstream spillway for Pond 18.

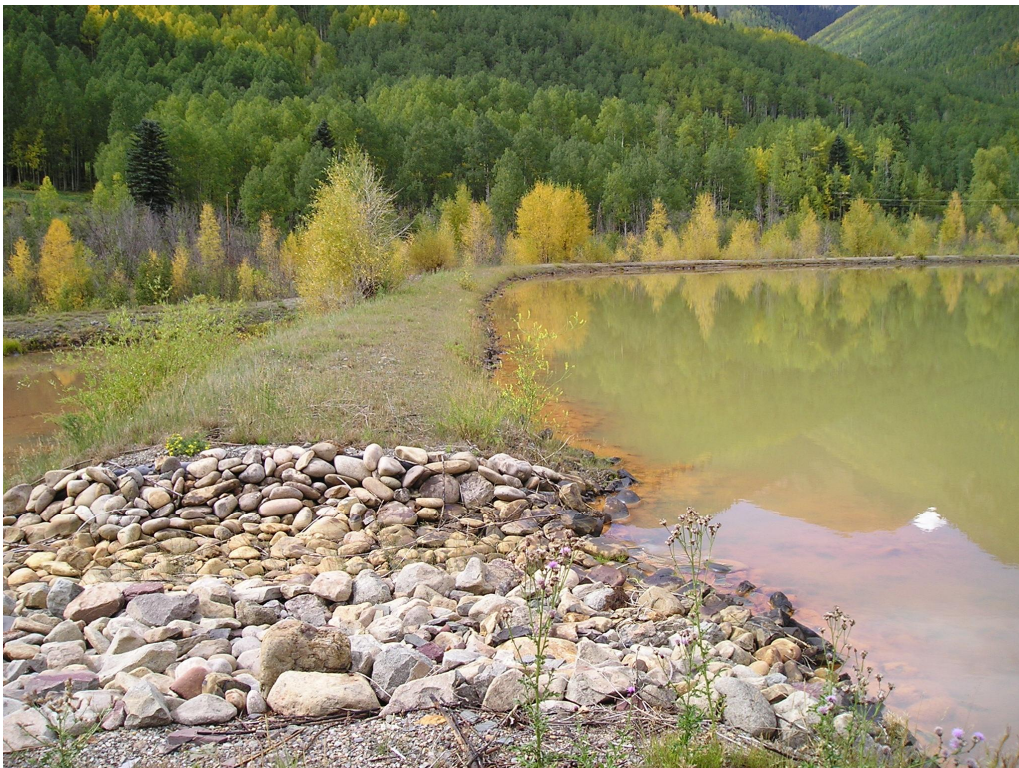
8. Broad-crest weir spillway.

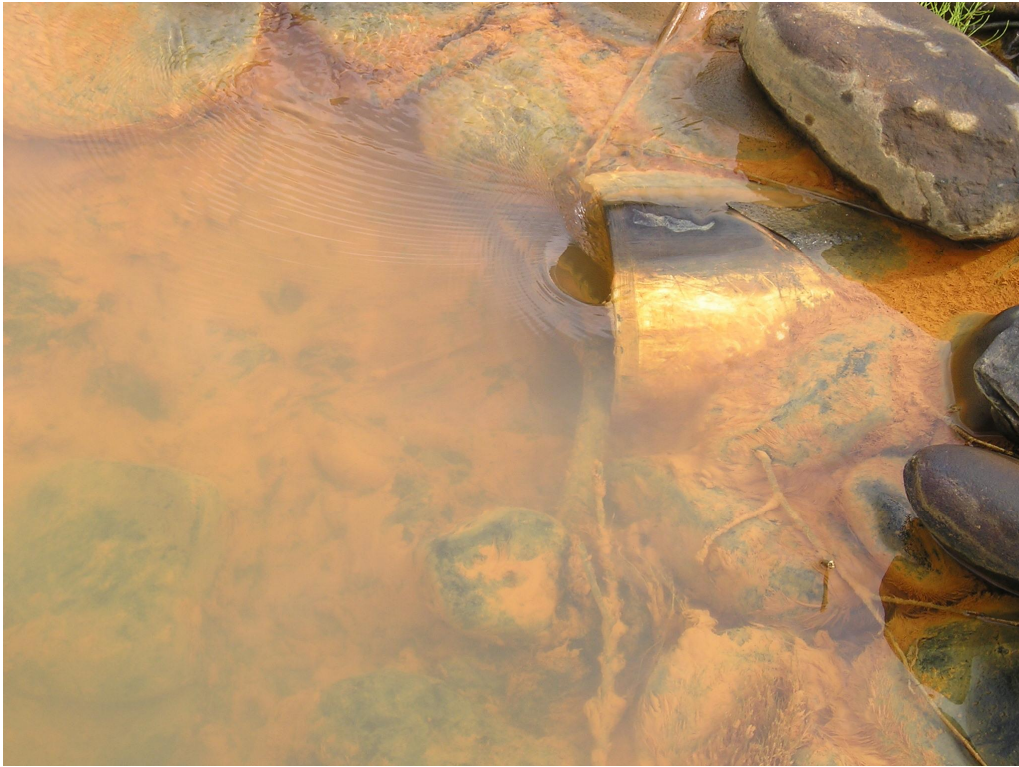
9. Single discharge culvert situated beneath spillway.

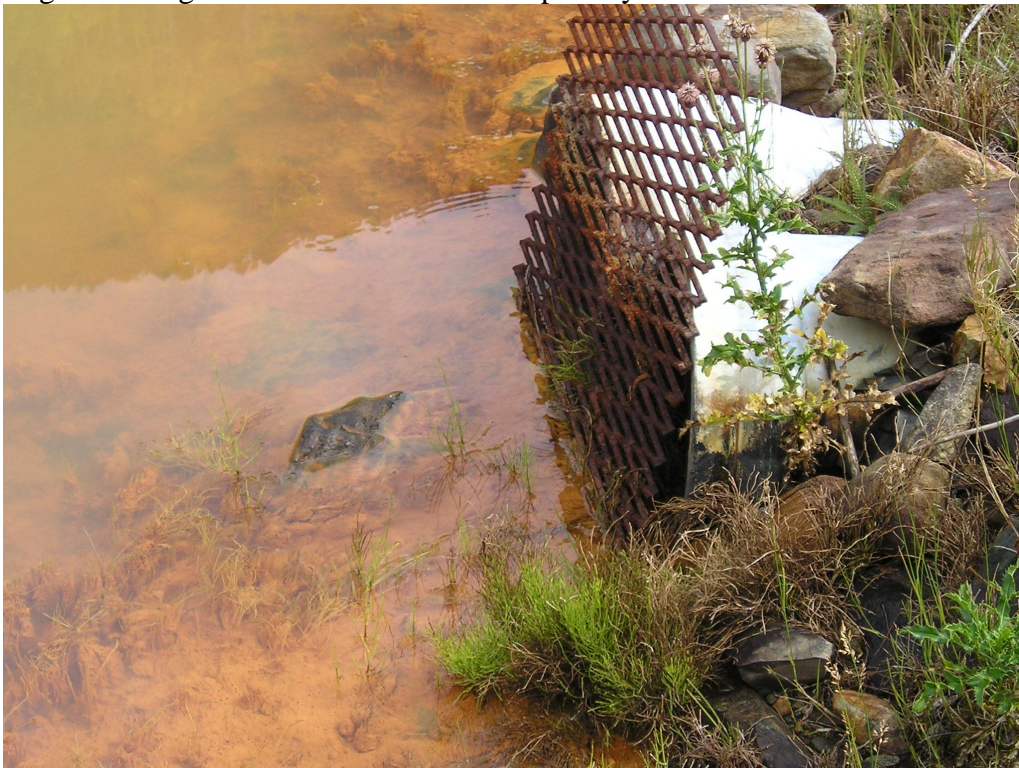
10. Side-by-side discharge culverts near spillway.

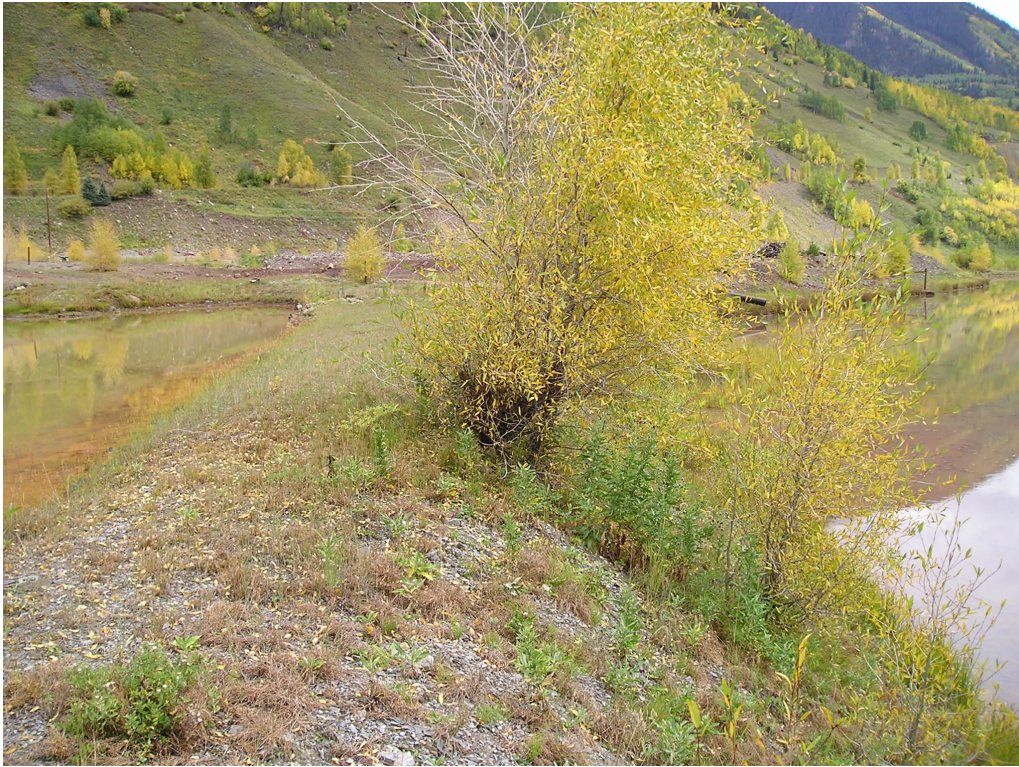
11. Embankment between Pond 15 and Pond 18, with vegetation.

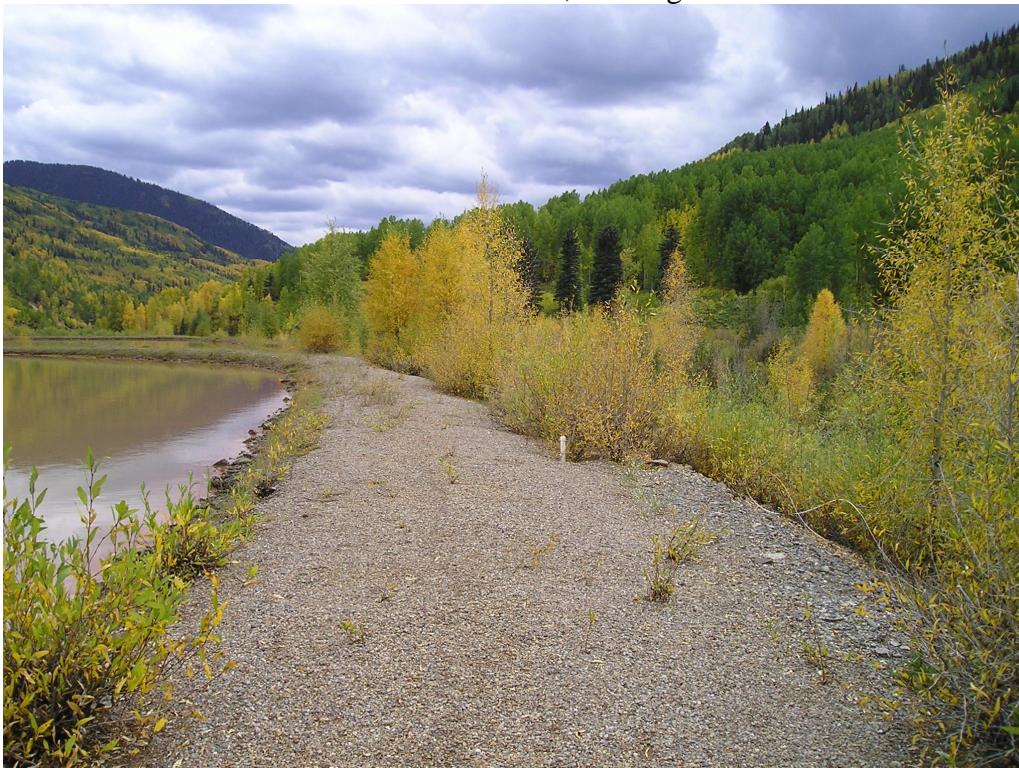
12. Pond 18 and embankments, looking west, existing piezometer in center of picture.

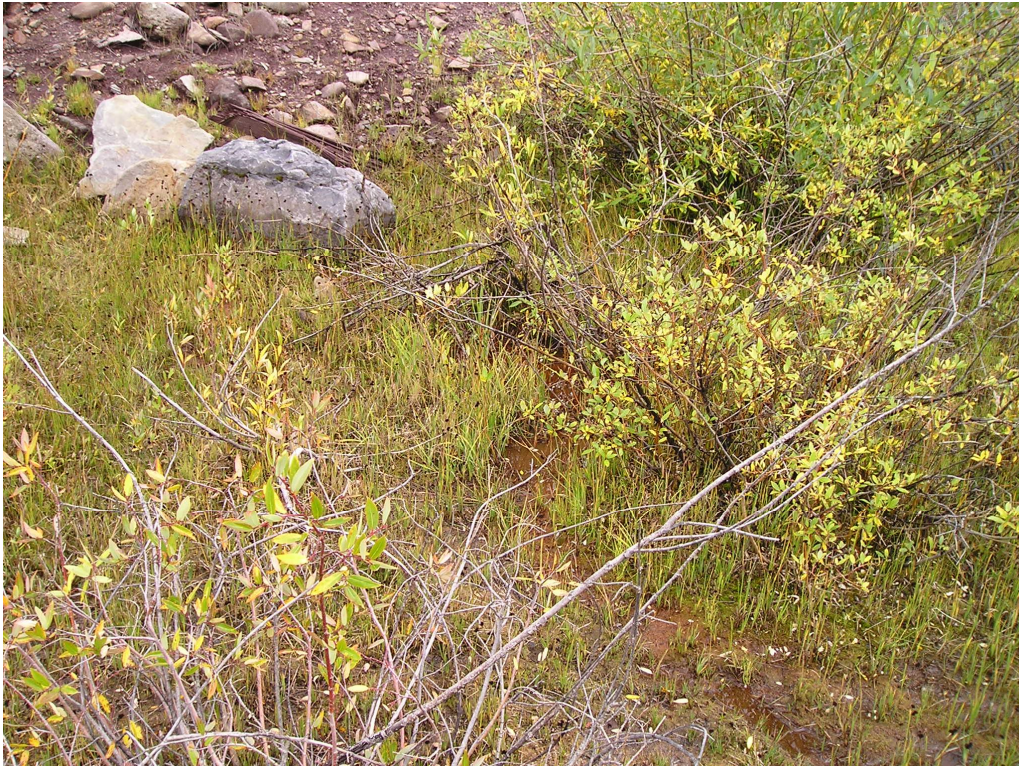
No apparent signs of settlement or slope instability were observed on the embankment during the site visit. Erosion along the interior banks of the pond appeared to be minor; related to wave action. Some erosion was observed at the inlet to Pond 18; no additional erosion along the interior banks was noted. Erosion on the downstream slopes was difficult to observe due to excessive vegetation, in areas, and the presence of rip rap armoring on the slopes. The downstream slopes appeared to be in good condition with no visible erosion or head cutting of the embankment. Seepage at the toe of the embankment was observed along the north side of the pond. The most notable seepage was observed along the northeast side of the pond. Water observed from the seep appeared to have a red tint, but was generally clear.

13. Seepage at the toe of the embankment along the north side of the pond, as shown in photo 15.

Seepage was encountered at the toe of the Pond 18 embankment along the northeast side of the pond which may be impacting the Dolores River. We recommend that further design consideration be made to address the seepage by improving or modifying the embankments. Further consideration would be based on the current condition and geotechnical characterization of the embankment.

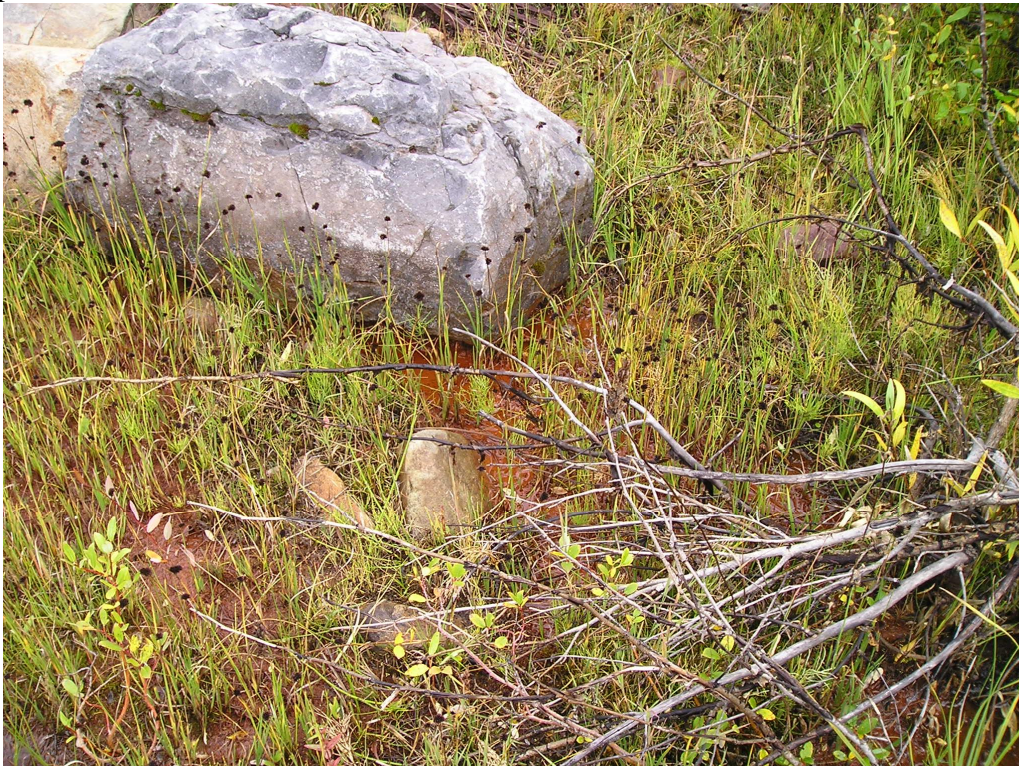
14. Seepage at the toe of the embankment along the north side of the pond, as shown in photo 15.

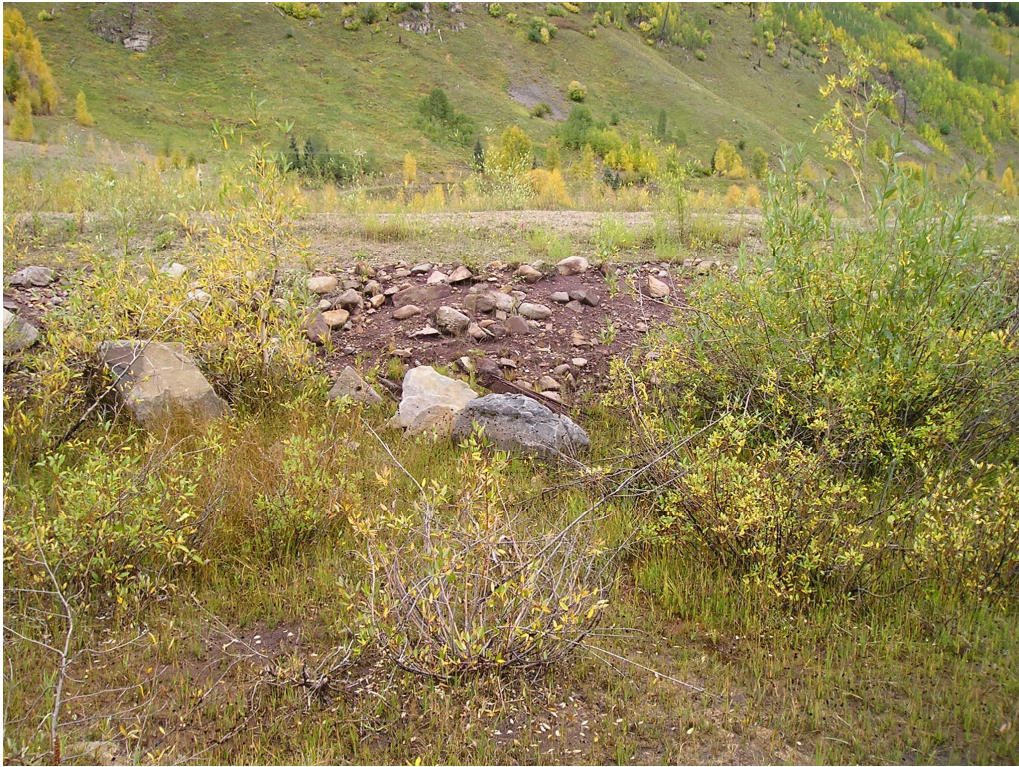
15. Location of seep shown in photo 18.

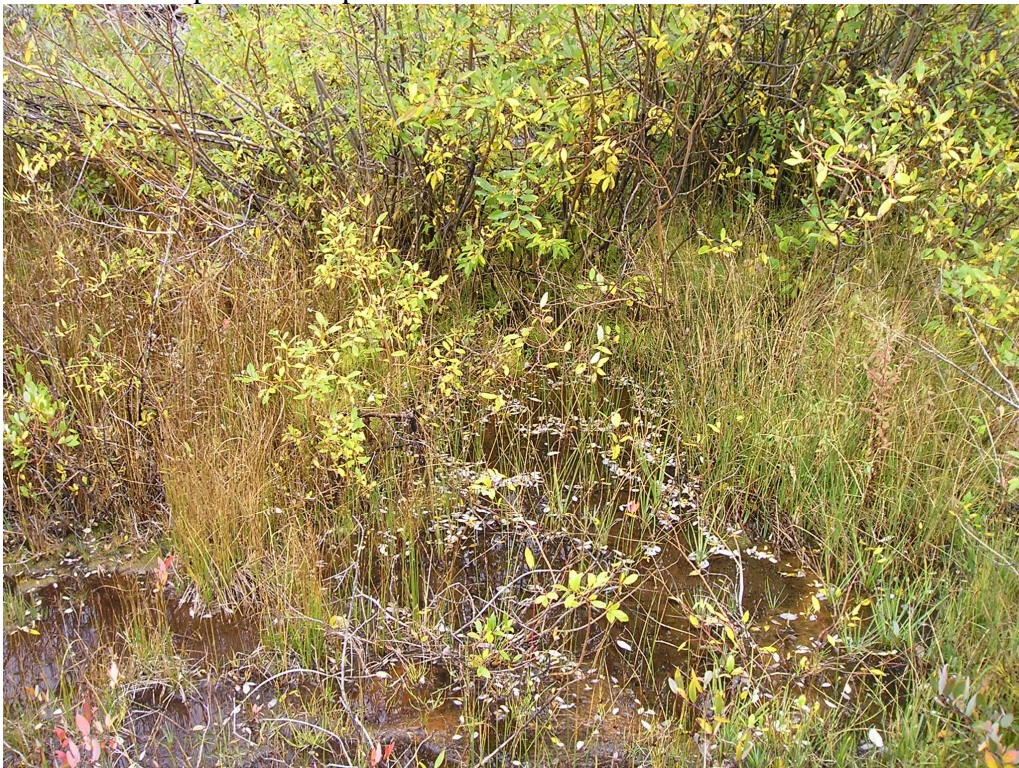
16. Seepage at the toe of the embankment along the north side of the pond.

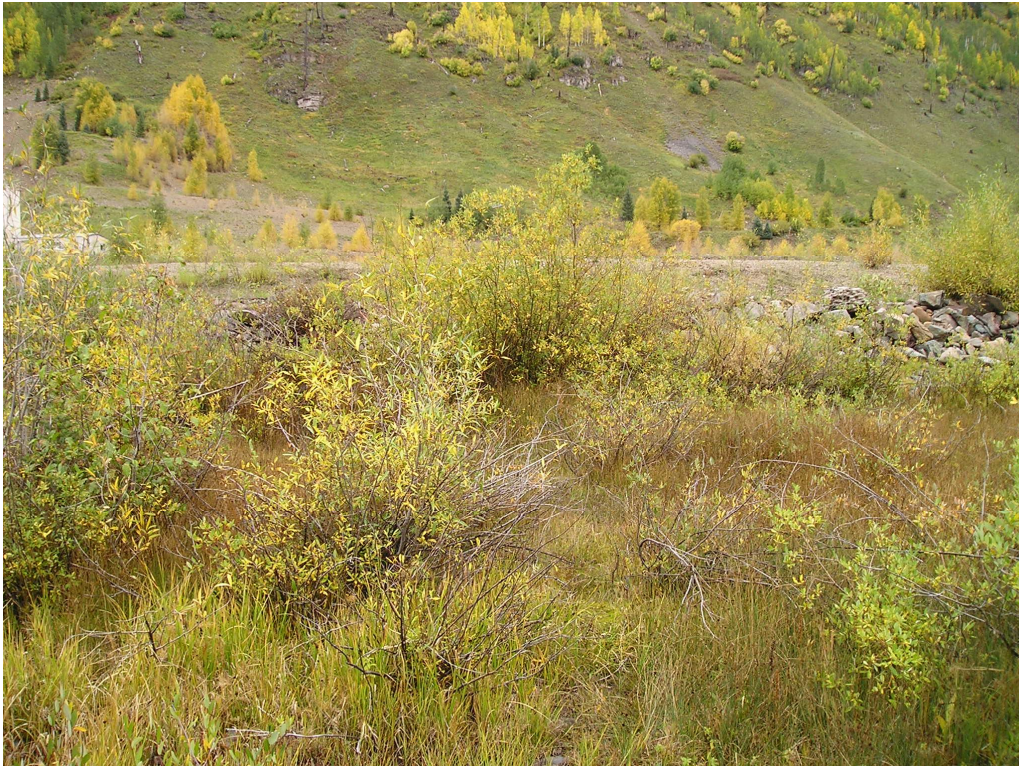
17. Location of seep shown in photo 18.

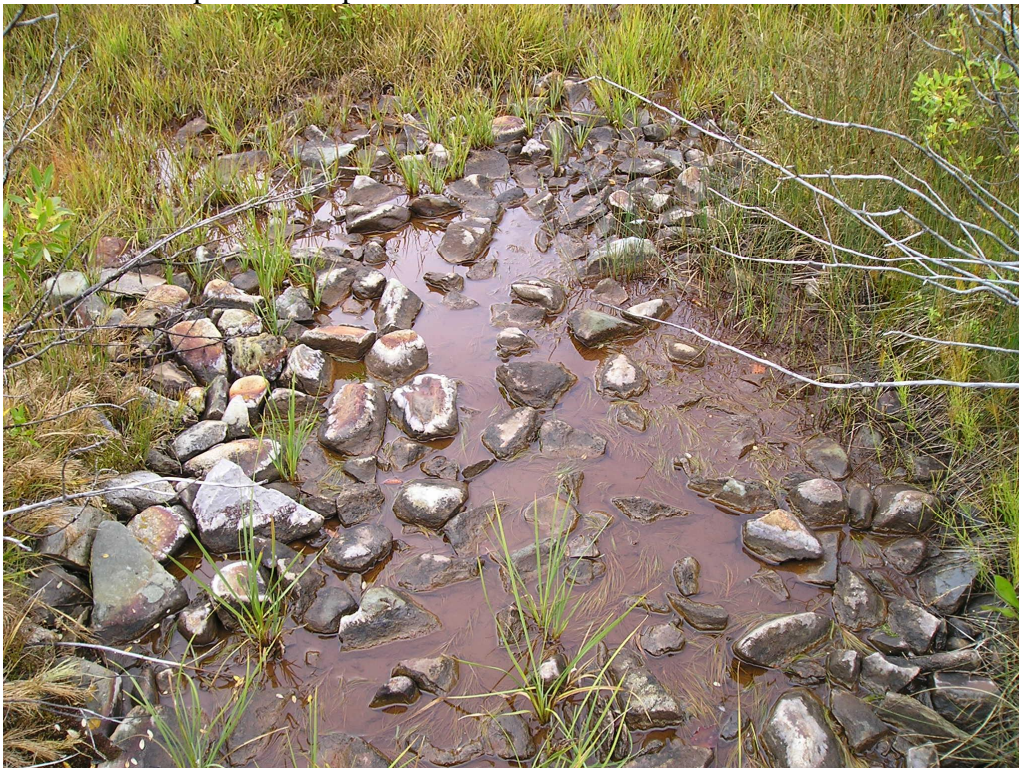
18. Seepage at the toe of the embankment along the north side of the pond, as shown in photo 17.

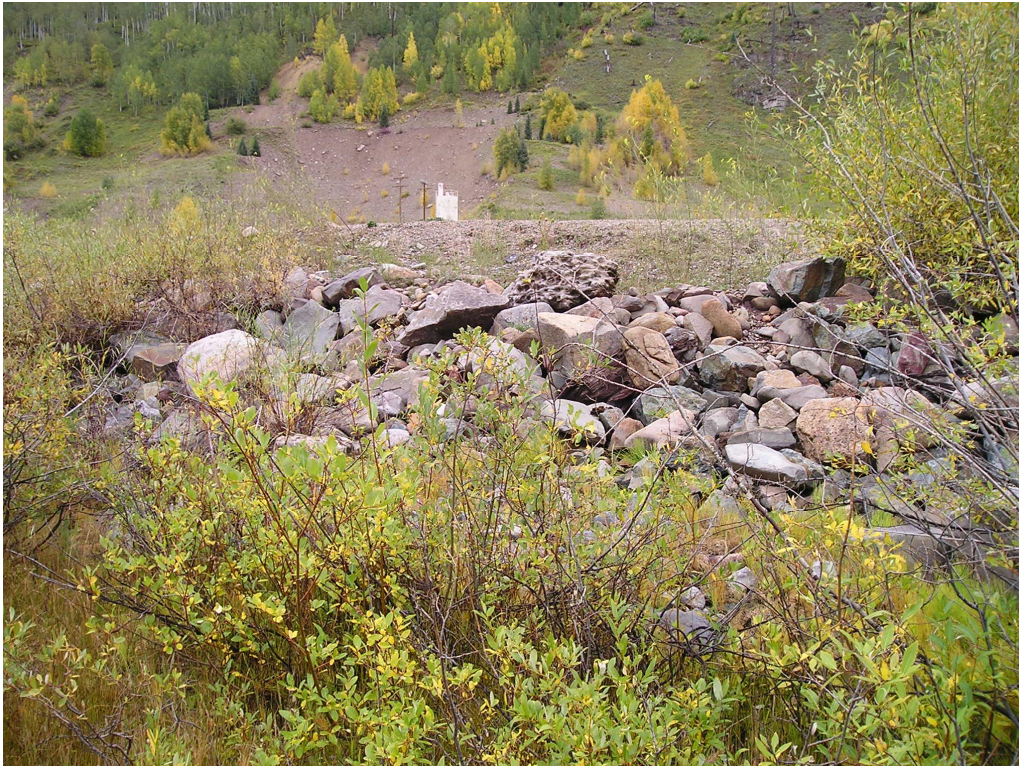
19. Downstream slope and riprap on north side of pond.

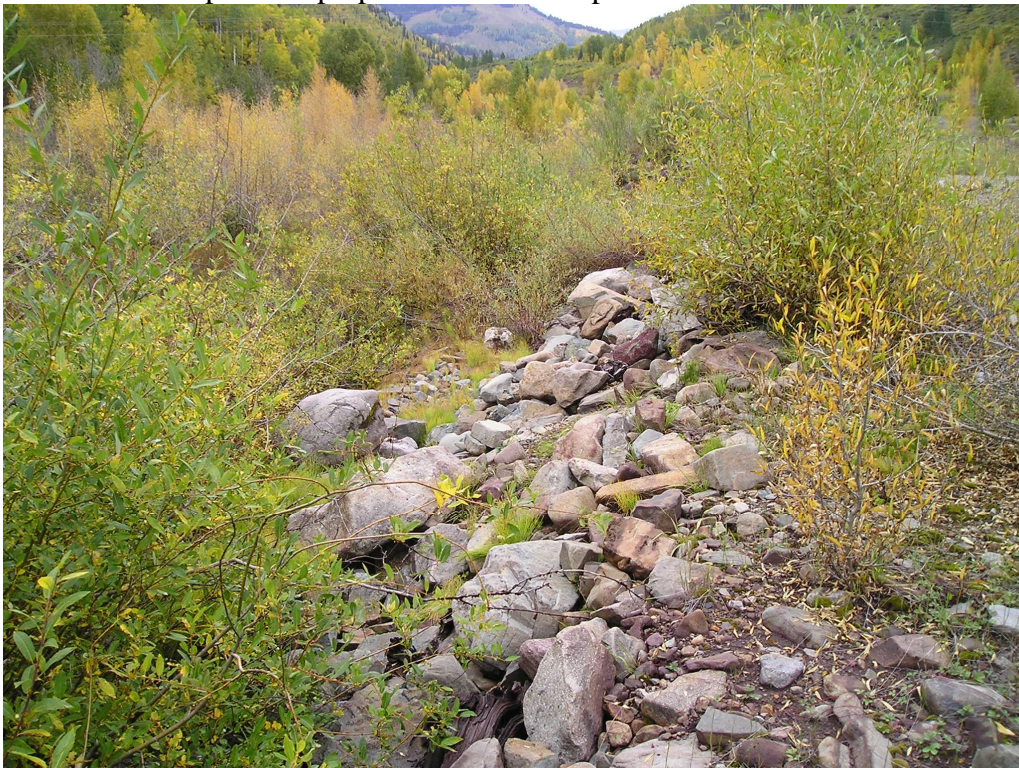
20. Downstream slope and riprap on north side of pond.

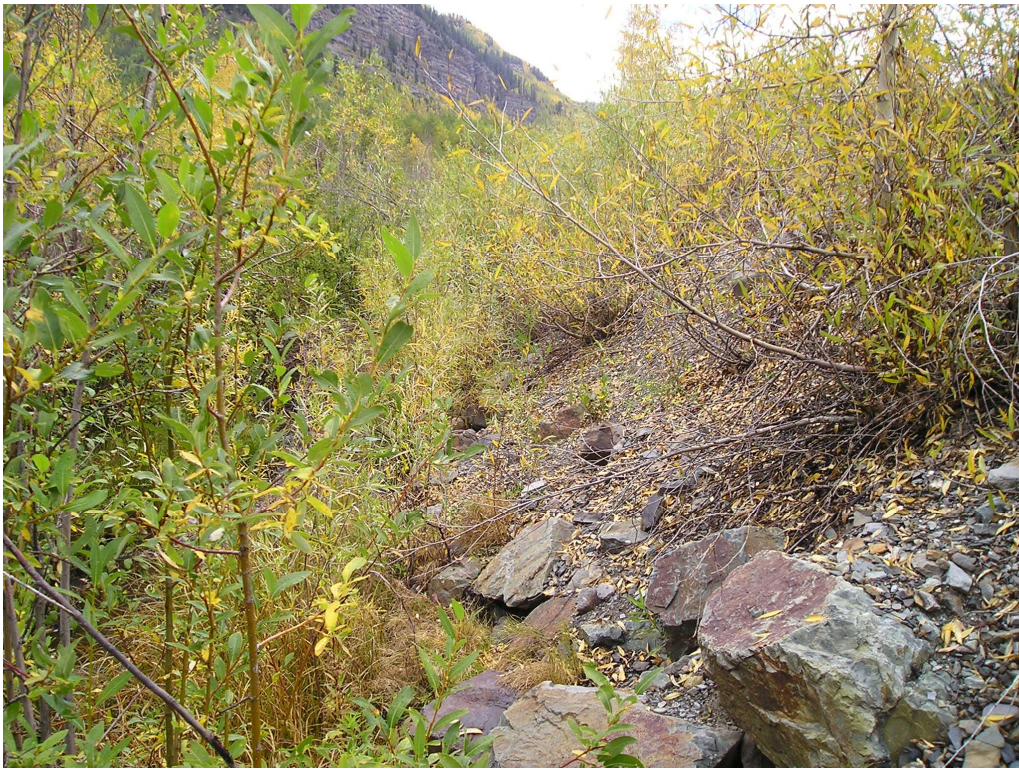
21. Downstream slope and riprap on north side of pond..

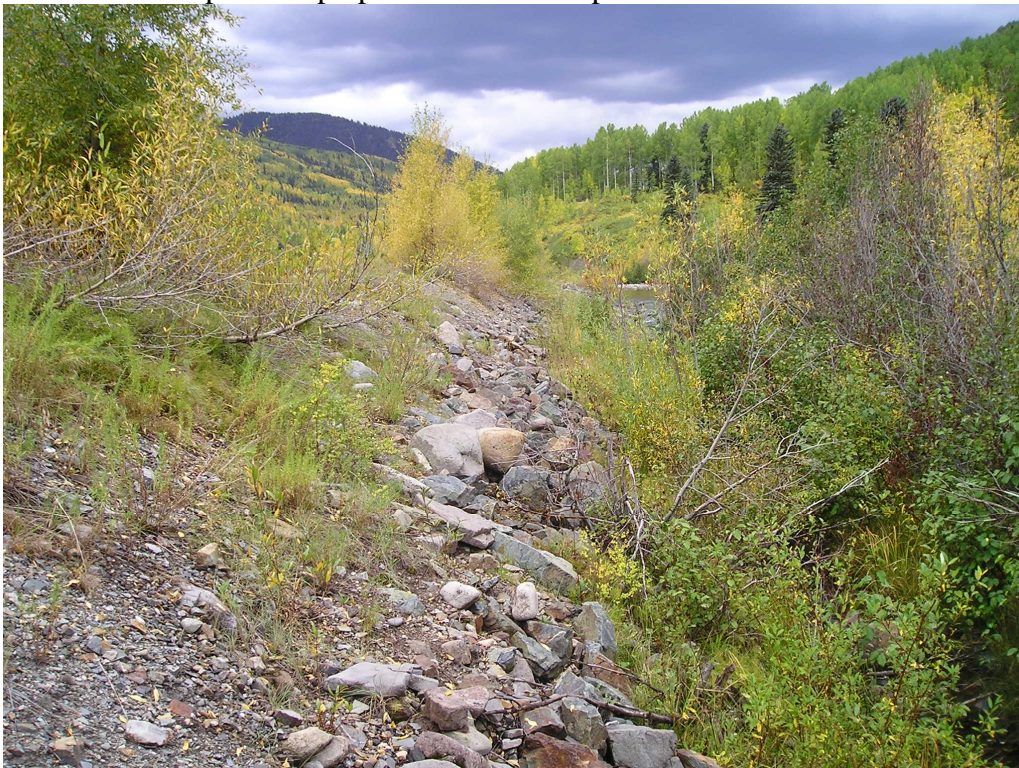
22. Downstream slope and riprap on north side of pond.

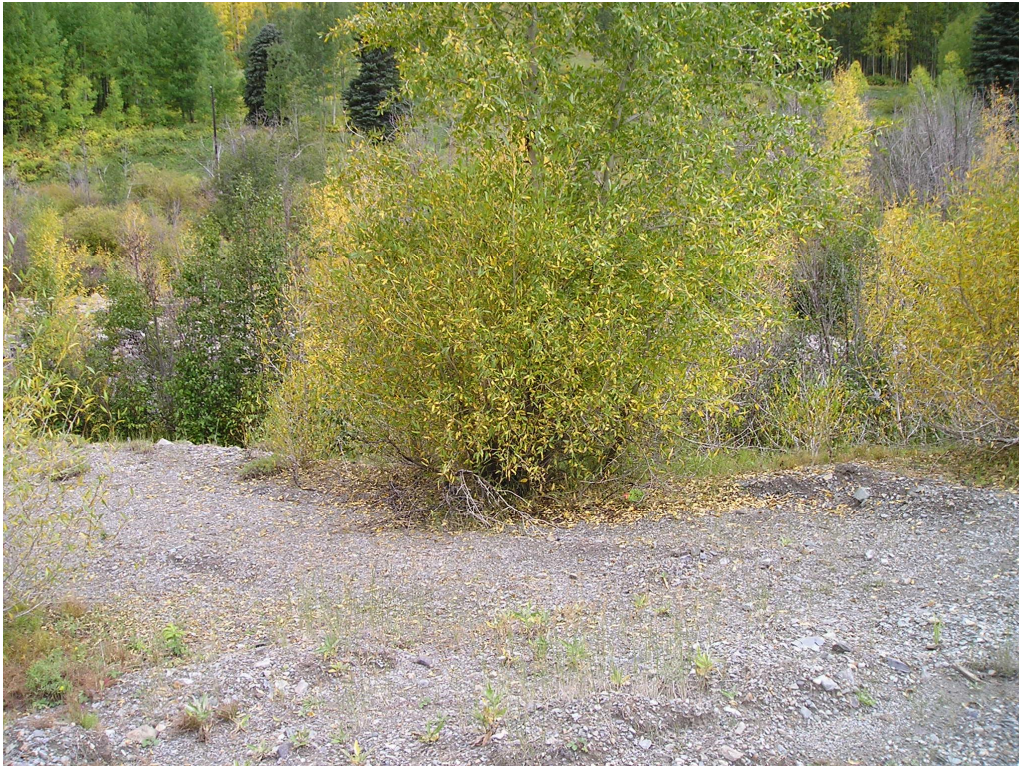
Vegetation is present over a majority of the embankments; it is particularly dense on the North side of the pond(s), nearest the river. Trees and bushes with large root systems may provide preferential flow paths for water seeping through the embankments, increasing the potential for added seepage and slope instability. We recommend removing trees and bushes, and maintaining the embankments free of vegetation with exception to surface grasses which reduce the potential for erosion and provide shallow slope stability.

23. Vegetation on the embankment.

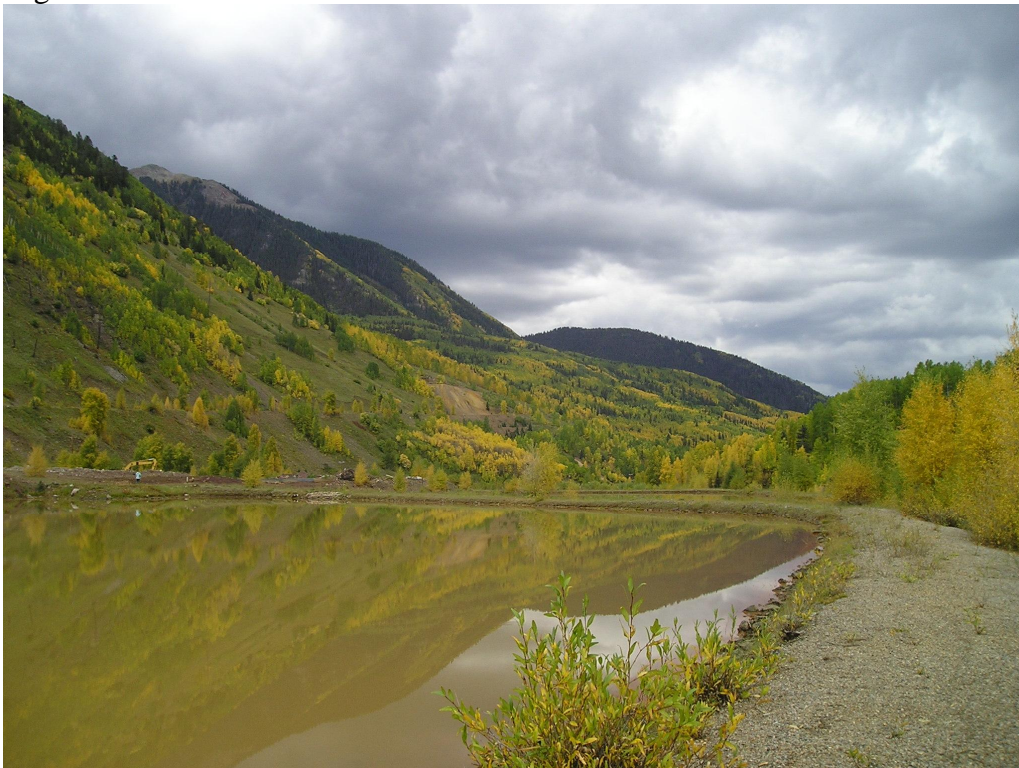
24. Pond 18 and embankment, looking southwest.

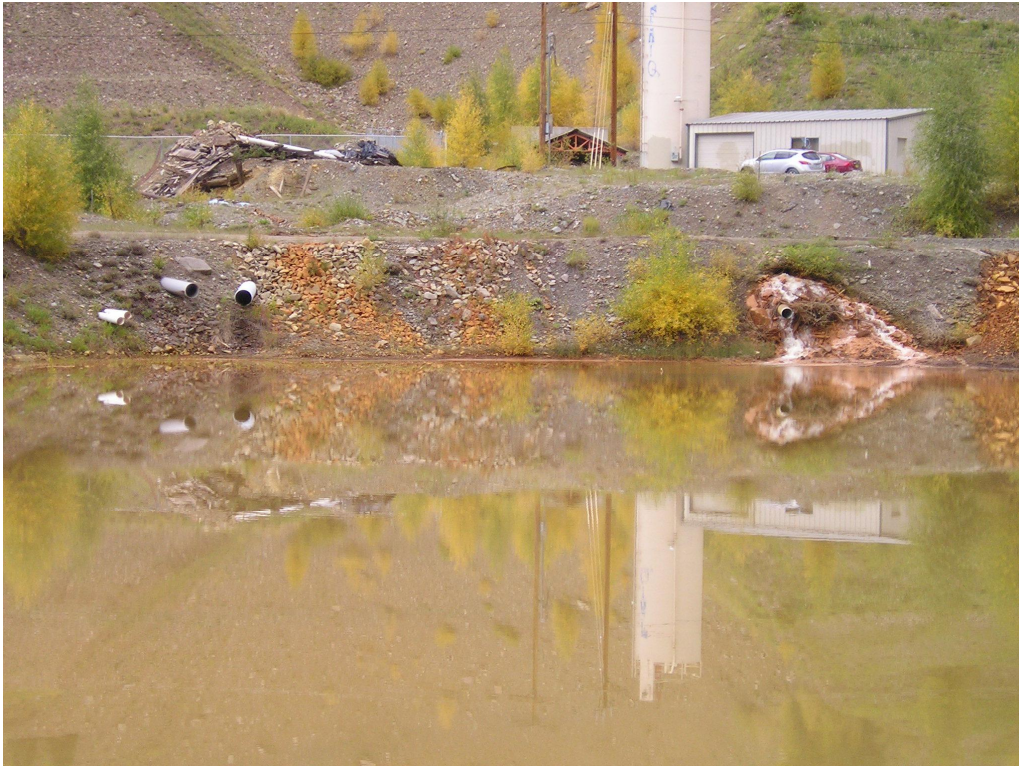
25. Inlet culverts to Pond 18.

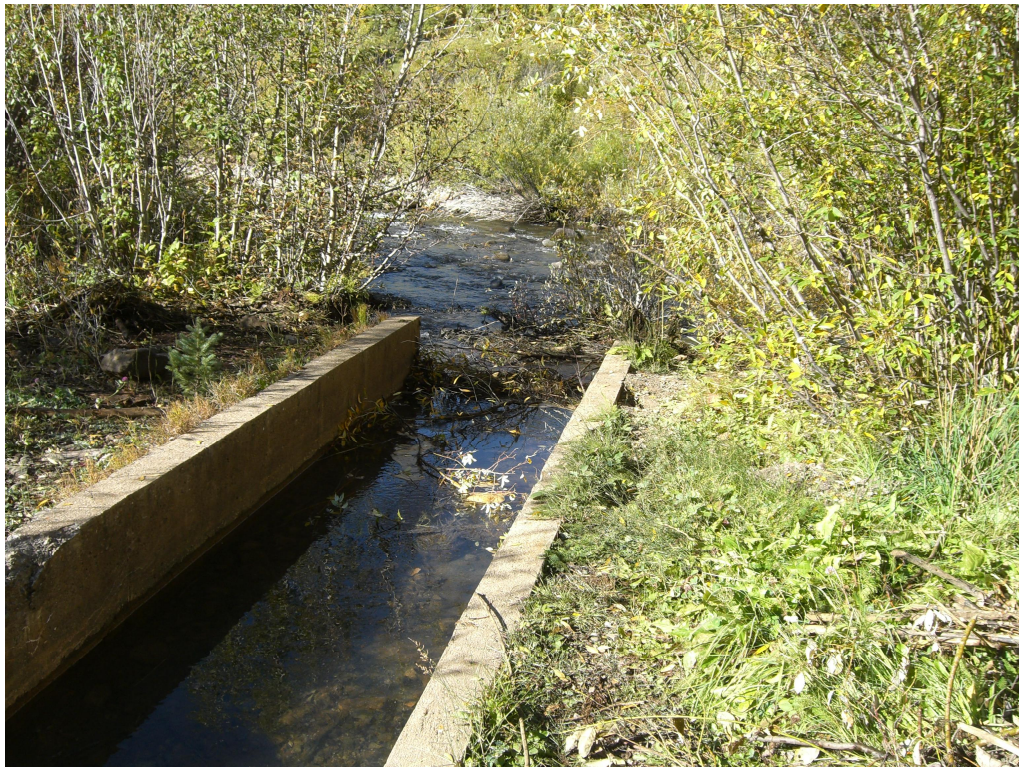
26. Discharge to Dolores River.

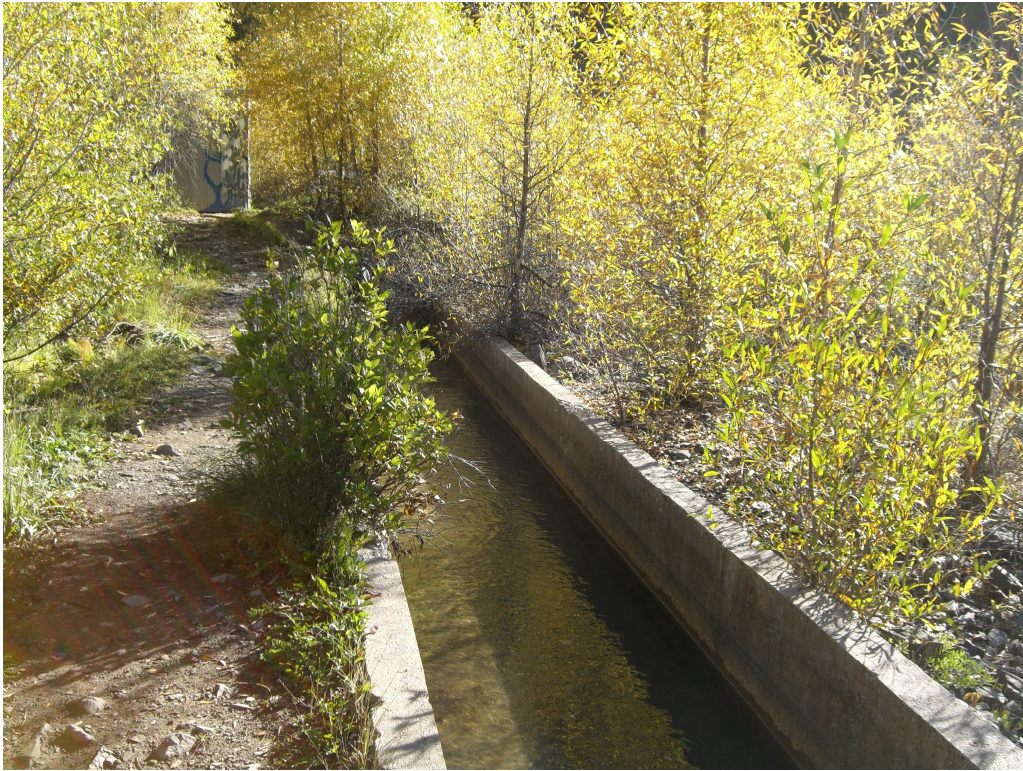
27. Discharge channel to Dolores River.
